Emergency sealant enables on stream butterfly valve repair

Saudi Aramco's validation testing of breakthrough butterfly valve sealant technology

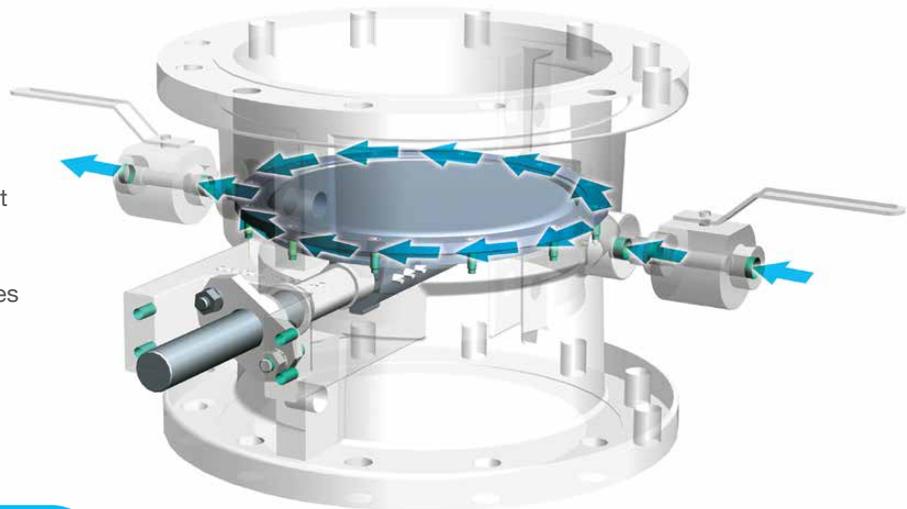
TYPICAL SEALANT FLOW PATH

SPIRES® enables badly damaged butterfly valves to be repaired in situ

The solution incorporates an emergency sealant system as a fundamental design feature of butterfly valves. Should the primary seal fail, a secondary sealant is injected into a runner behind the disc to compensate for any seat leakage when the valve is closed.
